ANNUAL REPORT

1992

Transportation Safety Board  
of Canada

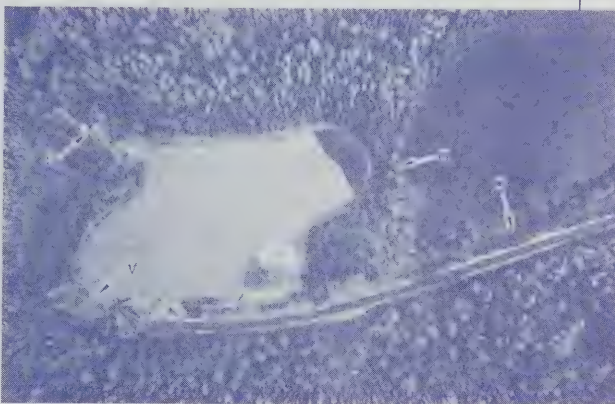
provoqué une baisse soudaine du niveau d'eau dans le lac adjacent à la voie. L'eau a alors arrêté d'exercer une pression sur le terrain sous l'assise des fondations de la voie, entraînant l'effondrement du terrain et du ballast et laissant la voie suspendue dans le vide. D'après l'analyse de la visibilité, l'équipe du train de marchandises n'aurait été capable de voir le vide sous la voie qu'au dernier moment, puisque ce vide se trouvait à la fin d'un tournant de la voie ferrée. Les stéréogrammes aériens du lieu même de l'accident et des environs ont révélé la présence d'un autre endroit le long de la voie où les caractéristiques géographiques étaient semblables à celles du lieu de l'accident. Si le barrage de

*La photographie aérienne verticale montre l'effondrement de l'assise des fondations de la voie à l'endroit "A" provoqué par la rupture d'un barrage de castor à l'endroit "B", le stéréogramme aérien du lieu même de l'accident et de ses environs a révélé qu'au point "C" la voie pourrait s'affaisser de la même manière si le barrage de castor situé à l'endroit "D" venait à se rompre.*

transmises à la société ferroviaire concernée, qui a pris des mesures de sécurité correctives. Dans ce cas, les stéréogrammes aériens ont permis aux enquêteurs de documenter et d'évaluer rapidement les modes de glissement de terrain sur le lieu de l'accident; ils constituent aussi une autre technique d'inspection utile pour surveiller et évaluer l'état des voies, en vue de prévenir d'autres événements.

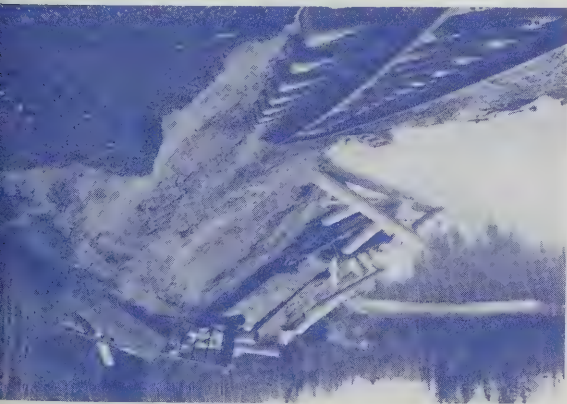
*Vue générale de l'assise des fondations de la voie affaissée à l'endroit "A", montrant le train de marchandises déraillé.*

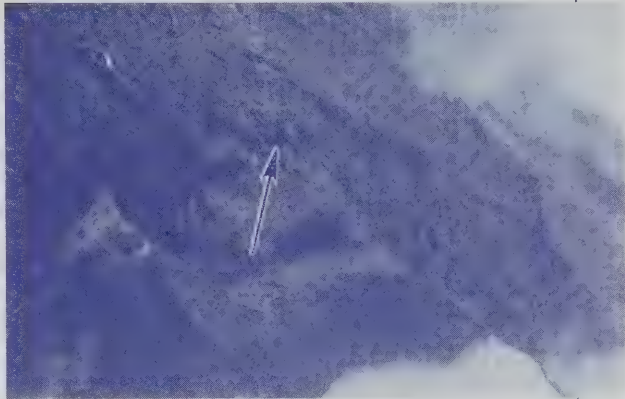
Lieu de l'accident de l'A310. La flèche indique le point d'impact.

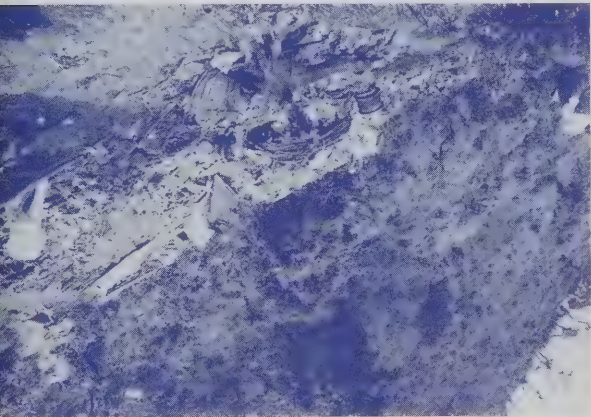
Le lieu de l'accident à l'ouest de Katmandou, qui s'est produit à une altitude d'environ 7 500 pieds-mer et à quelque neuf miles marins de l'aéroport international Tribhuvan, à Katmandou.

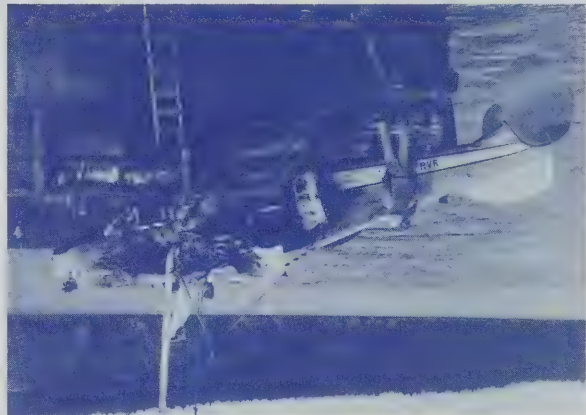
*L'examen de l'épave a révélé que les deux supports d'un siège de passager s'étaient détachés du rail de fixation.*

Bien que l'enquête sur cet événement se poursuive, l'examen de l'épave a révélé que les deux supports d'un siège de passager s'étaient détachés du rail de fixation. Comme les trous des boulons de fixation dans les supports du siège avaient été mal placés, les trous de boulons correspondants dans la pièce insérée du rail de fixation l'étaient eux aussi. Bien que ce problème ne visait qu'un seul siège de l'hydravion, le BST a

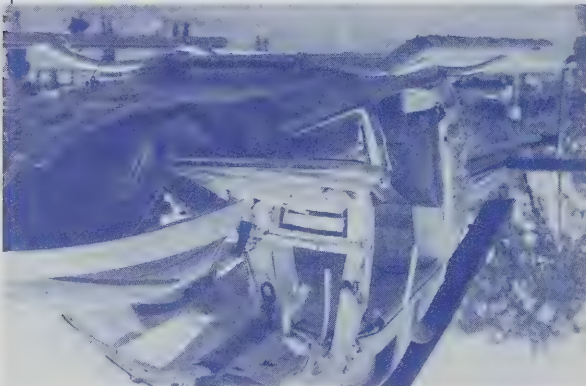
*Le Bell 206 a été lourdement endommagé, mais le pilote est parvenu à poser l'appareil sur un terrain de stationnement vide.*

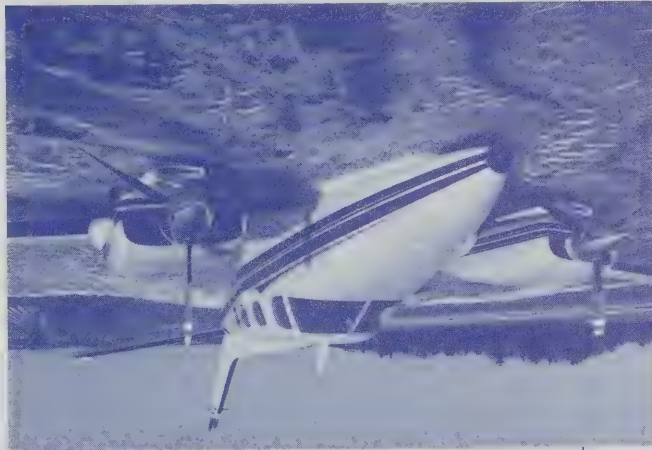
L'enquête a révélé que le train principal droit n'était pas sorti probablement parce que de l'eau s'était introduite dans la gaine du câble de verrouillage train rentré pendant une opération de nettoyage avant le vol. Cette eau aurait gelé pendant le vol et la glace aurait empêché l'ouverture du verrou train rentré du train principal droit.

Le BST a suggéré à Transports Canada de conseiller aux exploitants d'aéronefs Beechcraft et d'autres aéronefs dotés du même type de train d'atterrissage de prendre des mesures afin de

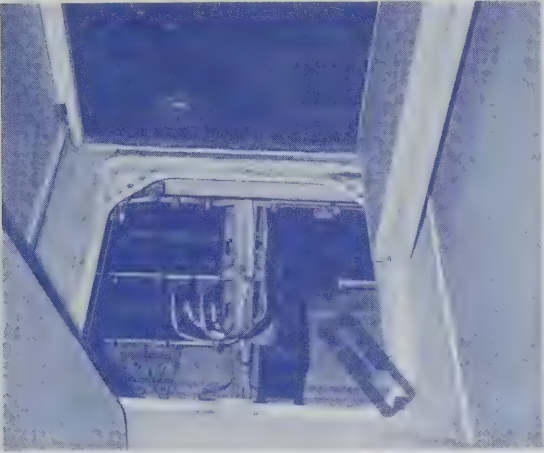
Après l'atterrissage de l'avion à Halifax, on a trouvé de l'eau sur le plancher du compartiment électrique et avionique. Il y avait des indices de présence d'eau à l'intérieur du calculateur du pilote automatique et à l'intérieur du bloc de commande de l'équipement de radionavigation numéro deux.

Les planchers du vestibule et de la toilette des appareils BAE sont censés être recouverts d'une membrane caoutchoutée à revers adhésif afin de prévenir toute fuite d'eau à travers les panneaux de plancher. La membrane de l'appareil en

*De l'eau a été trouvée sur le plancher du compartiment électrique et avionique.*

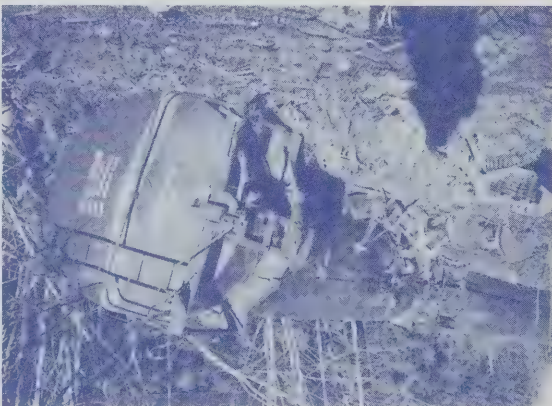
d'inspections périodiques des trains, puisque les limites prescrites visent l'usure des pièces individuelles et non de l'ensemble des pièces. Des réparations ou des examens plus approfondis des pièces de bogie n'avaient pas été effectuées, les propriétaires de wagons ne remboursant pas les compagnies de chemins de fer canadiennes pour ce type de travail.

*Le Bureau a recommandé l'établissement de limites prescrites pour l'usure de l'ensemble des pièces de bogie de tous les wagons loués en service sur les chemins de fer relevant de la réglementation fédérale.*

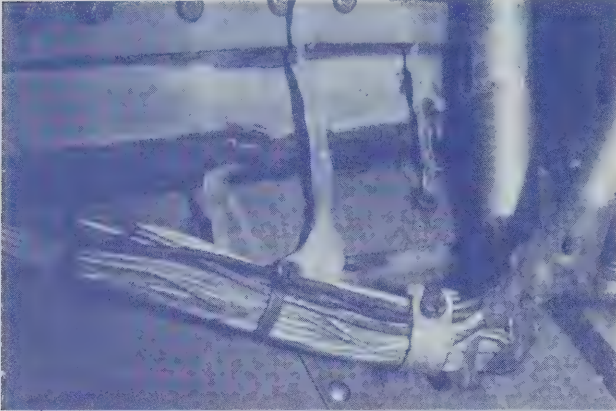
*Gros plan de la section B, glacon sur le panneau oblique qui goute sur la ferrure de la poulie d'aileron.*

À la suite de la participation du représentant accrédité, la NTSB a recommandé à la FAA d'émettre une consigne de navigabilité exigeant l'installation d'un système de drainage dans les logements du train d'atterrissage sur tous les DC-9 et les appareils de la série MD-80 visés.

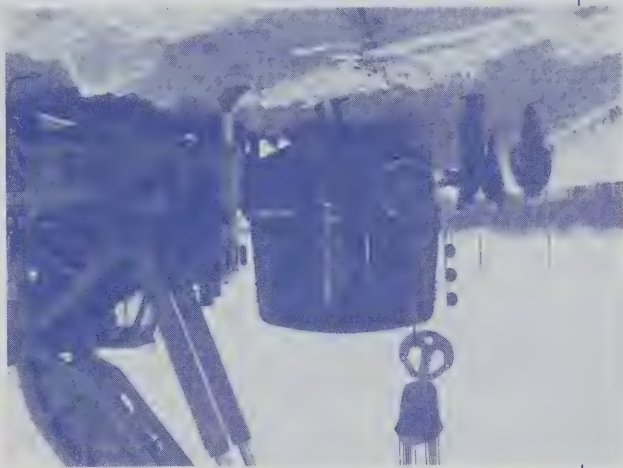
De janvier 1991 à mars 1992, trois accidents distincts ont mis en cause des ruptures d'essieux de trains de voyageurs Léger Rapide et Confortable (LRC) de Via Rail. Comme il a été difficile de déterminer la cause du problème, le Bureau a recommandé la tenue d'inspections spéciales de tous les essieux des trains LRC en vue de détecter d'autres essieux défectueux avant qu'ils ne se rompent. Via Rail a volontairement mis toutes ses voitures LRC hors service afin d'en inspecter les essieux. Plusieurs autres essieux présentant des anomalies ont ainsi été découverts.

*Via Rail a volontairement mis toutes ses voitures LRC hors service afin d'en inspecter tous les essieux.*

À la suite de cette enquête, le Bureau a formulé cinq recommandations concernant la conception, la fabrication et l'entretien des essieux, en vue de prévenir d'autres ruptures d'essieux sur du

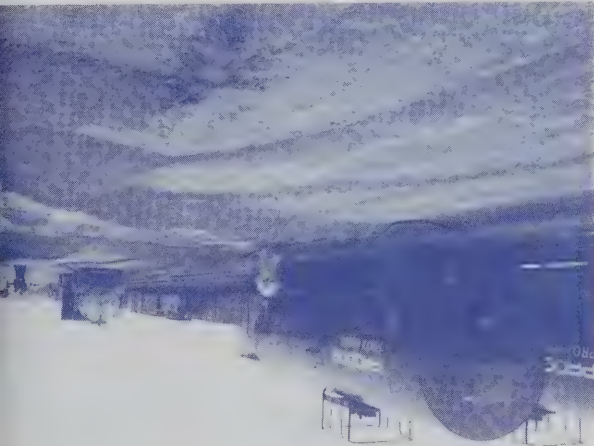
*Le programme de formation et les procédures de triage à butte comptent parmi les questions de sécurité étudiées par le Bureau.*

Jusqu'à maintenant, l'enquête du BST a permis de cerner des lacunes possibles dans le programme de formation des chefs de triage. Parmi les questions de sécurité étudiées, citons l'examen des programmes de formation et des procédures de triage à butte.

À la suite d'un incident survenu au cours d'une manœuvre le 30 avril 1992 dans une gare de triage à butte, une grande quantité d'acide sulfurique s'est déversée quand un employé inexpérimenté travaillant sans supervision directe a manœuvré un train-bloc transportant de l'acide. L'impact violent lors de l'attelage a provoqué d'importants dégâts matériels à l'un des wagons-citernes chargés, entraînant le déversement de son contenu.

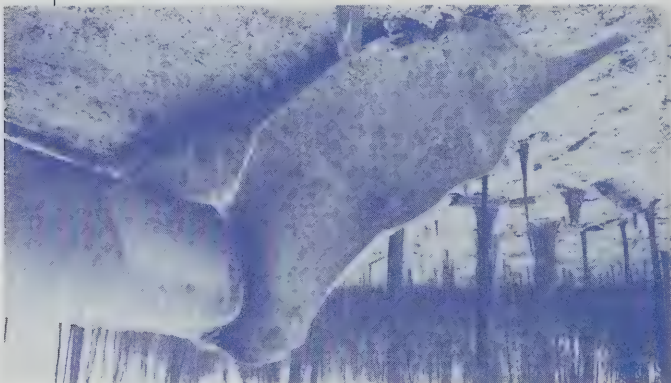
L'enquête a rapidement révélé que la paroi du gazoduc s'était rompue à cause d'une surcharge ductile, à une pression d'exploitation normale, après qu'une fissure ait progressivement atteint une taille critique. Sur les lieux de l'accident, on a pu constater qu'il s'agissait d'une fissuration par corrosion sous tension. L'information a été transmise à la société pipelinière pour qu'elle prenne les mesures de sécurité qui s'imposaient, et des échantillons des pièces rompues ont été envoyés au laboratoire technique du BST en vue d'y être analysés plus en détail. Une liaison permanente a été établie avec l'exploitant afin d'échanger les résultats techniques, comme la détermination de la vitesse de progression de la fissuration.

*Plans généraux de la partie rompue du gazoduc souterrain, montrant les dommages causés par l'explosion et l'incendie.*

fin de 1992. Entre-temps, compte tenu des conséquences éventuelles d'une rupture de gazoduc, le Bureau a formulé trois recommandations provisoires sur la sécurité concernant la détection et la réparation de fissures causées par la corrosion sous tension et les procédures d'exploitation des gazoducs sur lesquels de la fissuration par corrosion sous tension a été découverte ou sur lesquels il pourrait y en avoir. Le 21 décembre 1992, l'Office national de l'énergie a annoncé qu'il effectuerait une enquête par mémoires en réponse à ces trois recommandations, et qu'il réévaluerait également le programme d'entretien des producteurs qui avait été mis en oeuvre pour résoudre ce problème particulier.

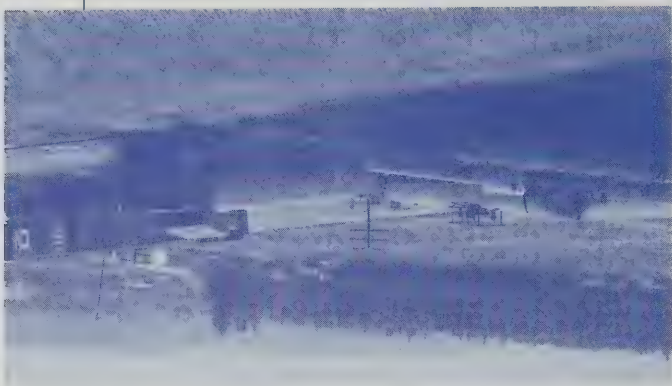
*L'accident ayant causé des fuites d'anhydride acétique et de soude caustique, il a fallu évacuer la ville de St. Lazare (476 résidents) pendant sept jours.*

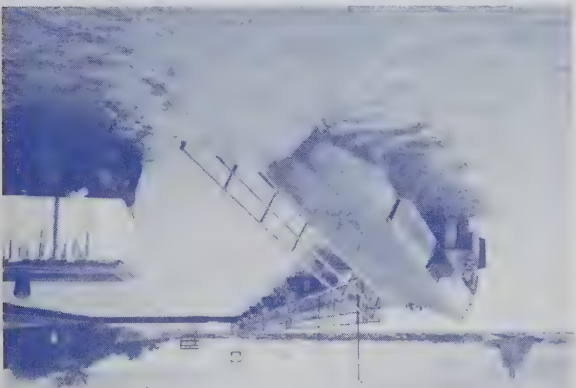
D'importantes avaries ont été rapportées, mais il n'y a eu aucune pollution.

tribord du navire a été troué (4 m sur 3 m), au-dessus du repère de tirant d'eau de 27 pi. (8,23 m). Une conduite de diesel de 2 po. (5 cm) a également été endommagée, mais comme elle était isolée, il n'y a eu aucune pollution. Personne n'a été blessé. Le quai ne pouvait plus être utilisé avant d'être réparé. Le navire s'est rendu jusqu'au quai du gouvernement pour y être réparé.

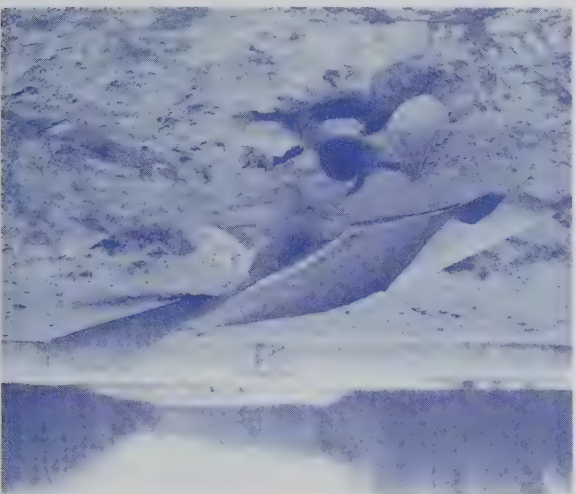
L'accident a touché une zone de la taille approximative d'un terrain de football.
